Blue Whale Report

FIRE INVESTIGATION REPORT WITH ORIGIN AND CAUSE REPORT

Cause Classification: ACCIDENTAL / UNINTENTIONAL — ORIGIN BATTERY UNDETERMINED

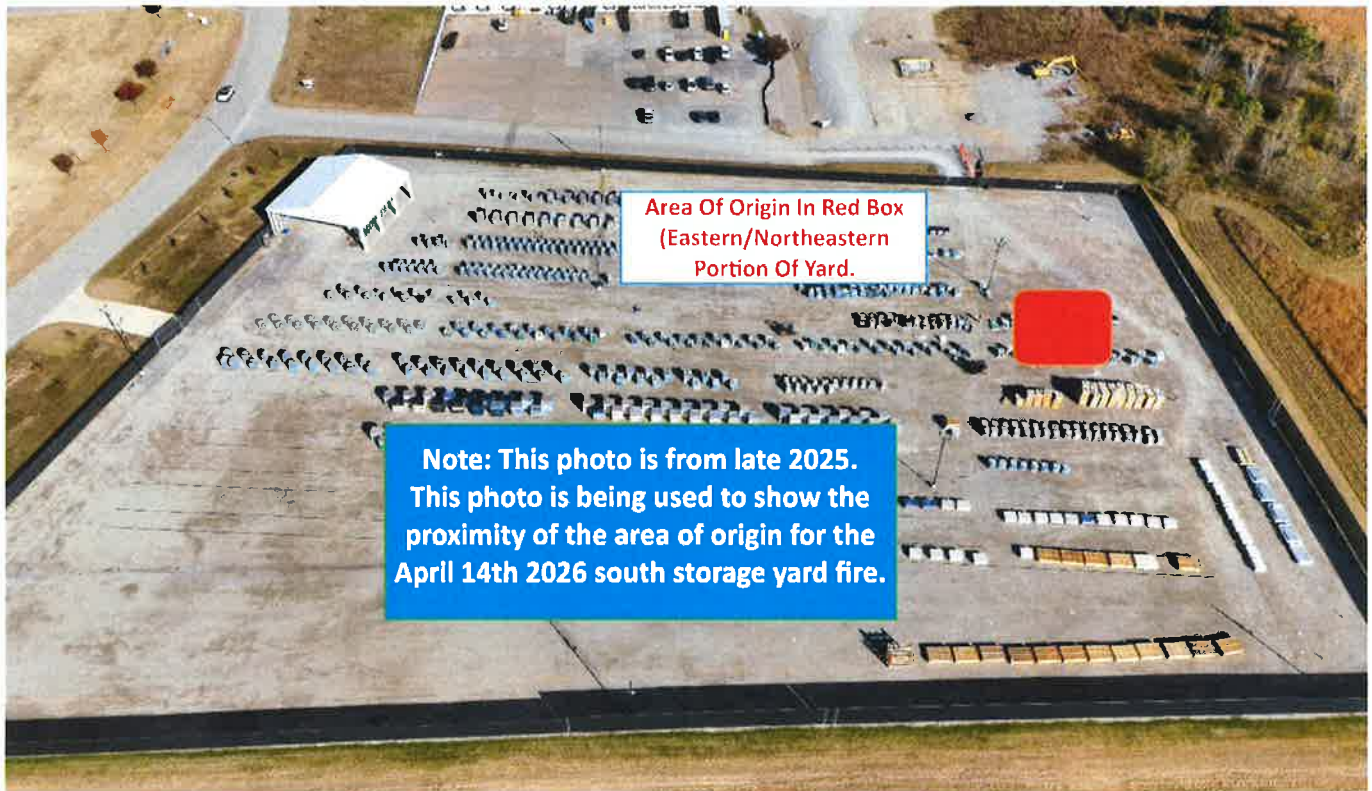
Note: Aerial photograph taken November 2025. Included to illustrate the proximity of the south storage yard to surrounding structures relative to the April 14, 2026 area of origin.

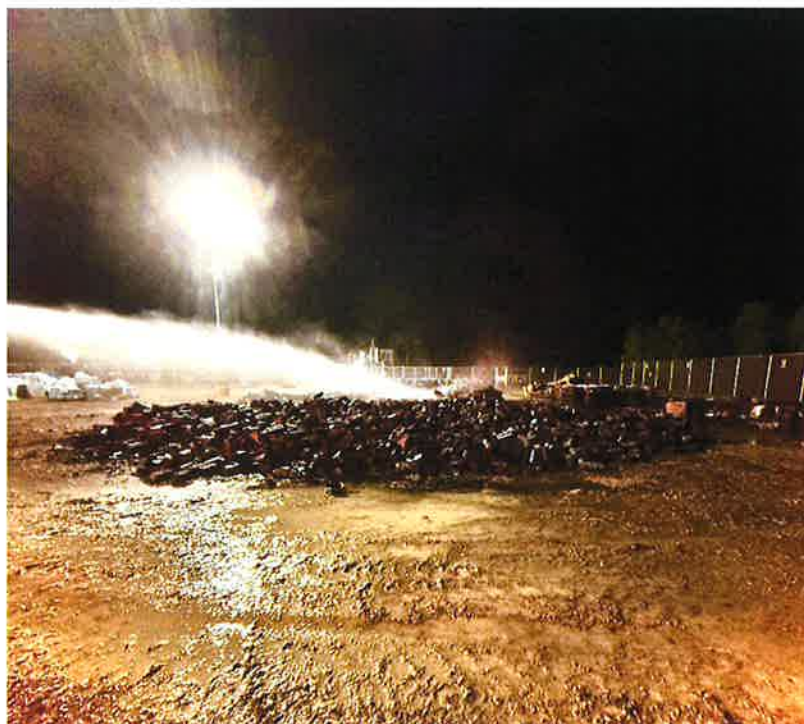
Note: Photo shown below is the fire debris which was spread out by the Blue Whale Materials using skid steers and forklifts. Photo dated: April 15th 2026.

A significant limiting factor of this investigation is the extent of scene disruption that occurred during suppression operations. Blue Whale Materials employees, acting at the direction of incident command, utilized forklifts and a skid steer to spread burning and adjacent battery product beginning at approximately 22:00 hours. This action was tactically appropriate and contributed to confinement of the fire to the storage yard; however, it produced the following investigative consequences:

- The original spatial arrangement of pallets, battery casings, and cardboard boxes was disturbed and destroyed prior to complete investigative documentation of the scene.
- Burn pattern indicators on individual pallets and boxes were disrupted or obliterated by mechanical displacement.
- Battery cells that may have represented the specific origin battery were crushed, scattered, or commingled with secondary-involvement product.

- Additional batteries not originally involved in the fire were damaged or destroyed during mechanical spreading.
- From approximately 23:00 hours on April 14 through approximately 04:30 hours on April 15, a skid steer and forklifts were used to spread remaining debris to a single layer during hot spot checks, further disturbing post-suppression evidence.

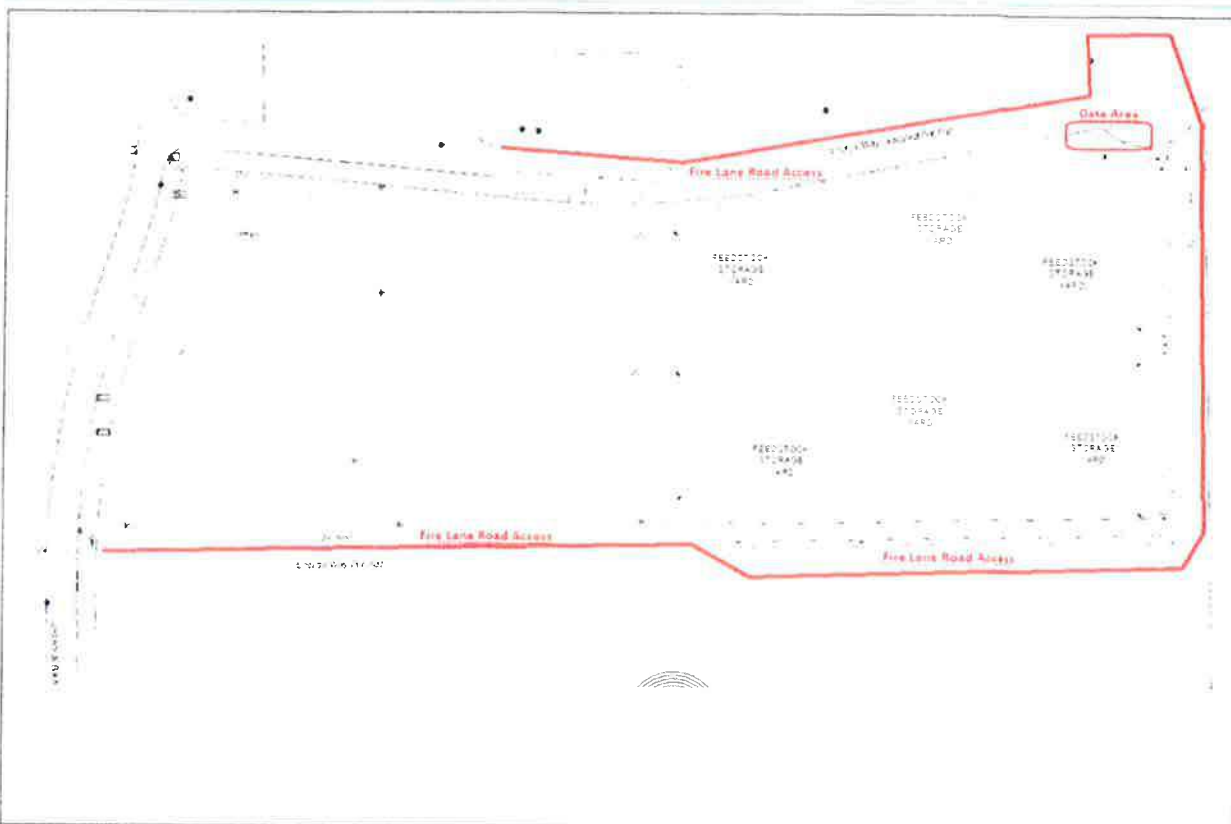
2 Fire Service Road Extension |

Background: *The City is requesting that BWM extend a fire lane road access capable of supporting aerial apparatus adequate for future emergency response operations around both the current and planned storage yards (See attached map.) The City is also requesting additional vehicle gates throughout the facility to allow adequate entry points into the storage yard*

What is BWM's plan and timeline for designing and constructing a fire service road capable of supporting aerial apparatus around the current and planned storage yards, with gates?
